# Crossville, TN Influent Drum Screen Evaluation 6/22/18

Re: Crossville, TN – Influent Drum Screen Evaluation

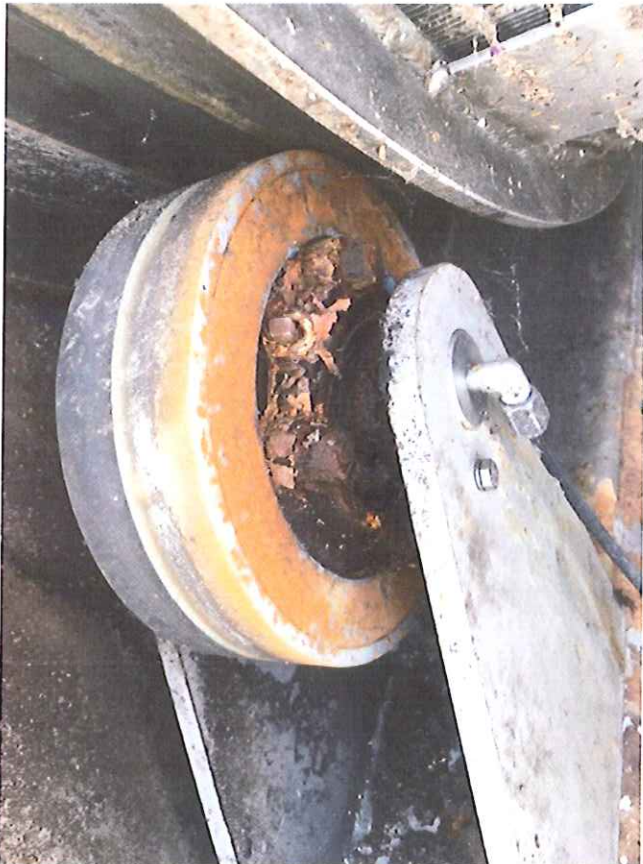
Corroded trunnion bearings.

4. Obtain a minimum of one complete set of replacement bearings, retainers, and components for one trunnion from Parkson to ensure the proper bearings are purchased. Once it is received, a competitive price from another vendor, such as Kaman (corporate vendor), can be obtained. Otherwise, four complete sets of replacement bearings can be obtained. This is dependent on the final costs obtained from Parkson. All bearings should be replaced.

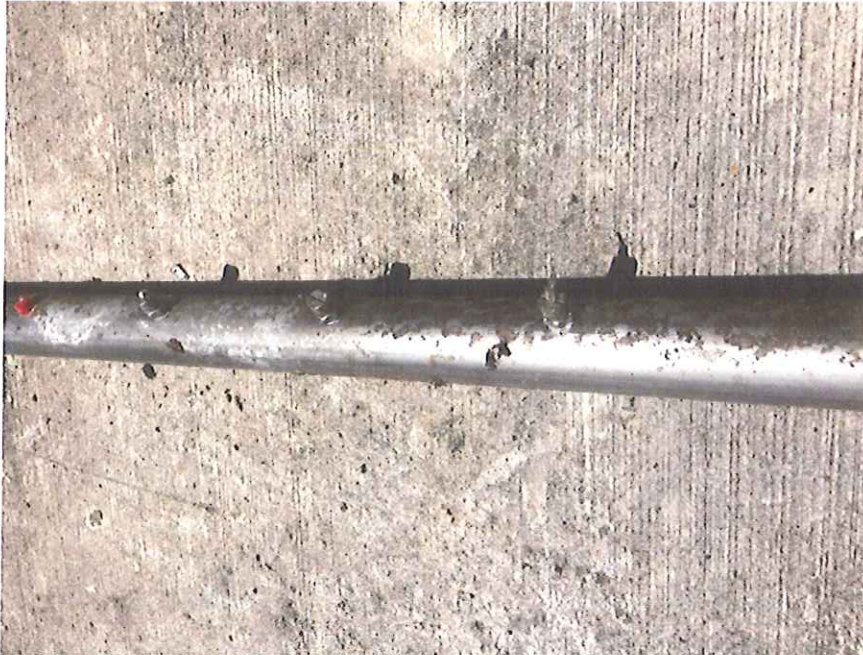
Spray bars with clogged spray heads.

1. Purchase new spray tips to replace the clogged tips on the existing spray bars. Prices from several vendors have been provided. Purchasing the same component from a supplier other than Parkson can save over \$465.

2. The threads on the spray bars appear to be damaged when the spray tips are removed. One option is to have a machine shop remove the existing spray tips and mount the correct size stainless steel nut over the hole and seal between the nut and spray bar. This will provide a clean thread to reinstall the new spray tips. Note that the spray tips need to be installed at a 10 to 15 degree angle from parallel to the spray bar. This will provide full spray against the drum for cleaning without interference from an adjacent spray tip pattern. See the operation and maintenance manual.

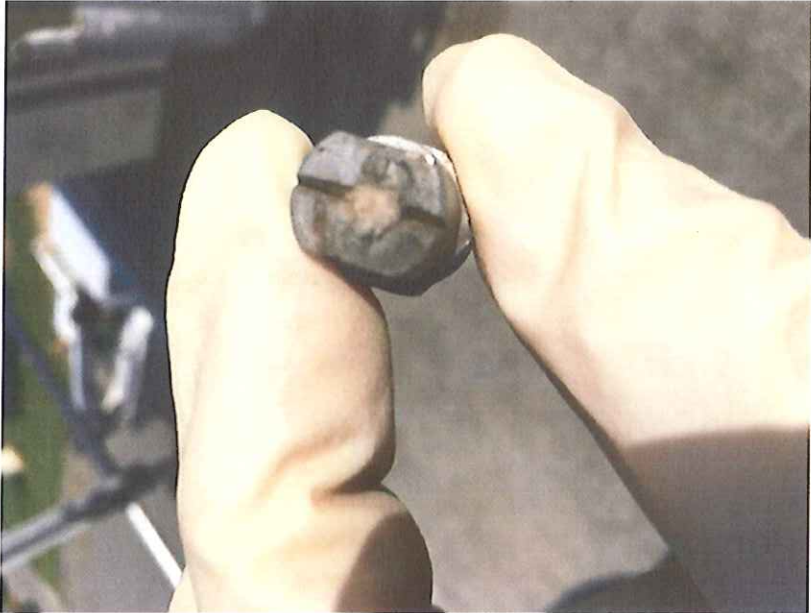
Clogged spray head.

3. Install a Y strainer upstream of the spray bars to capture any debris that may be in the plant water. Debris caused the existing spray tips to fail and likely subsequent overflows. The strainer is intended to prevent the same failure from occurring. The long term plan should be to return the final disk screens to service to capture the debris prior to reaching the plant water pumps.

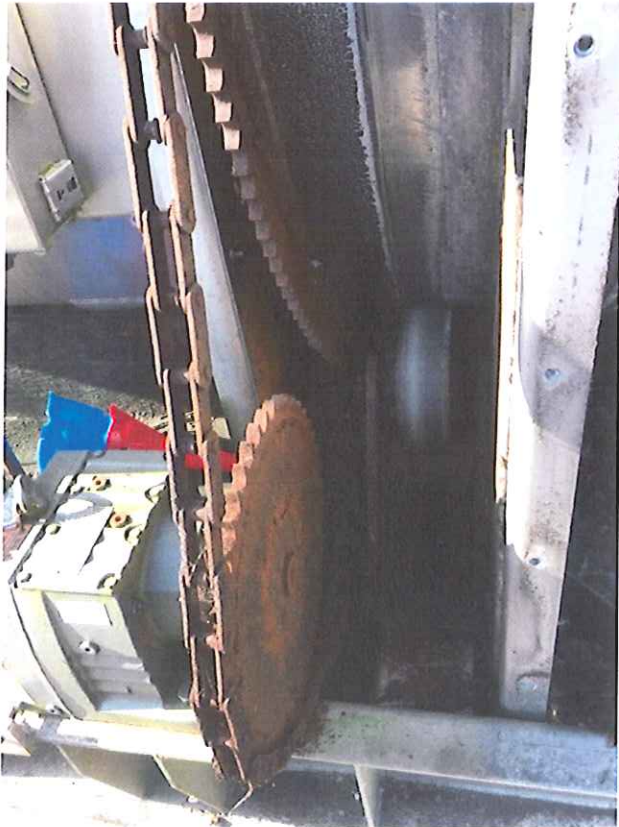
Corroded drive spur gear, drum gear teeth, and chain.

5. Purchase a new drive chain from Parkson and install after cleaning/dressing of the drive and drum gear teeth.
6. Purchase new guide pads, inner and outer, from Parkson and install.

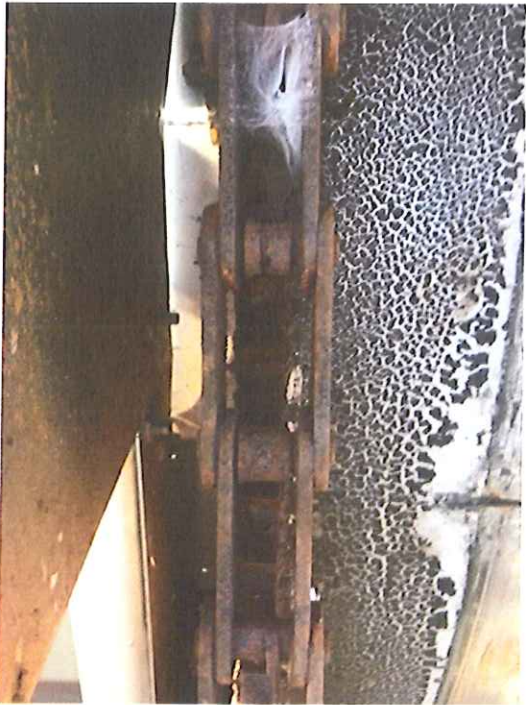
Corroded chain. Note that the link sleeves are partially or entirely gone from wear and corrosion.

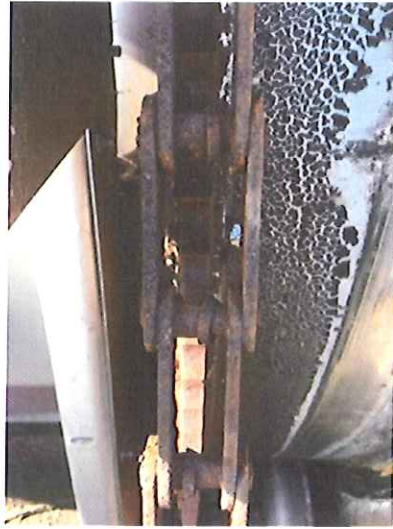
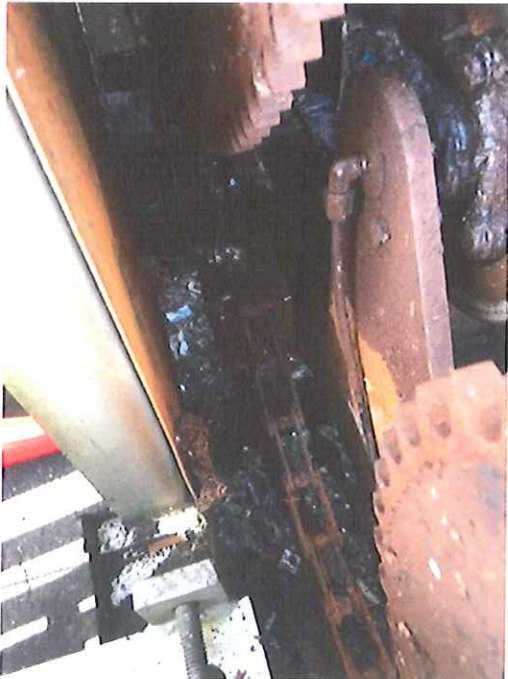
Automatic oiler in need of cleaning. Trunnion bearing needing replacement. Inner and outer guide pads requiring replacement are beyond the trunnion under the drum. Access under the drum will be required to complete exchange.

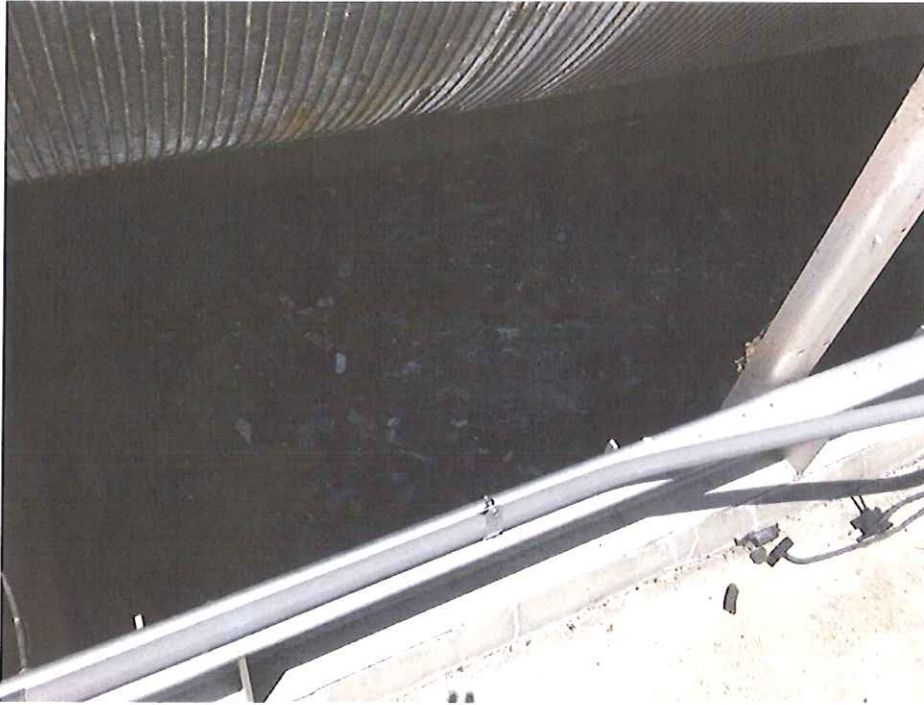
Debris in the catch basin after the drum screen. Debris from under both screens in addition to the discharge pipe should be removed to prevent discharge to the aeration basin.

7. Remove all the debris from under the drum screens and the receiving pipe leading to the aeration basins.
8. Remove and replace all oils and greases. Replace with new oils and greases per the O&M manual.
