SUBJECT: File No. LRN-2012-00738; Required Mitigation in Response to an Unauthorized Deposition of Fill Material into Jurisdictional Wetlands Located at Duer Soccer Complex Near Black Drowning Creek Mile 1.4L, Obed River Mile 34.6L, Crossville, Cumberland County, Tennessee

2nd NOTICE OF UNAUTHORIZED ACTIVITIES

FN LRN 2012-00738 City of Crossville Duer Soccer Field 5 ac wetland fill

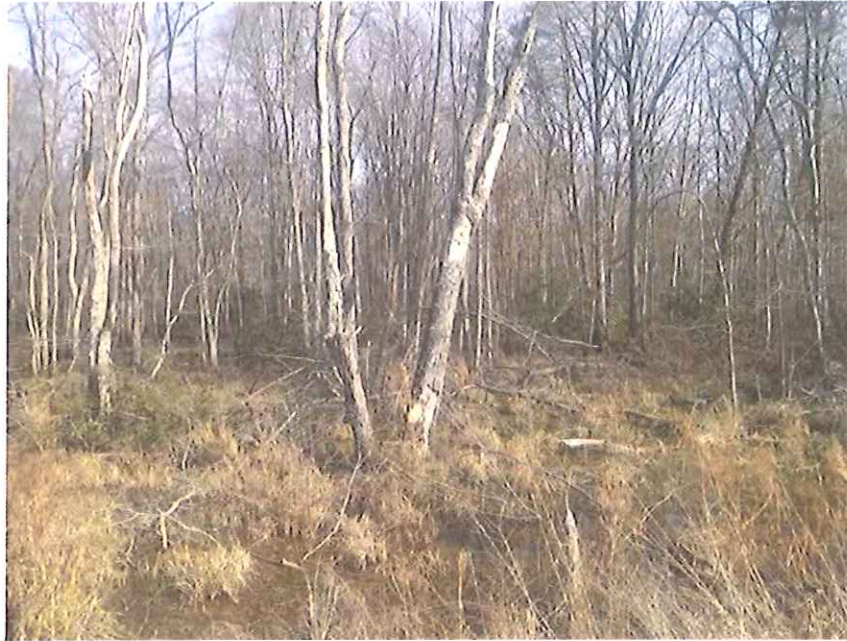
Name: Areas to the North

Photo taken facing North. Photo depicts hydrophytic vegetation and hydrology above the current soccer fields. Photo take neat Data Point I.

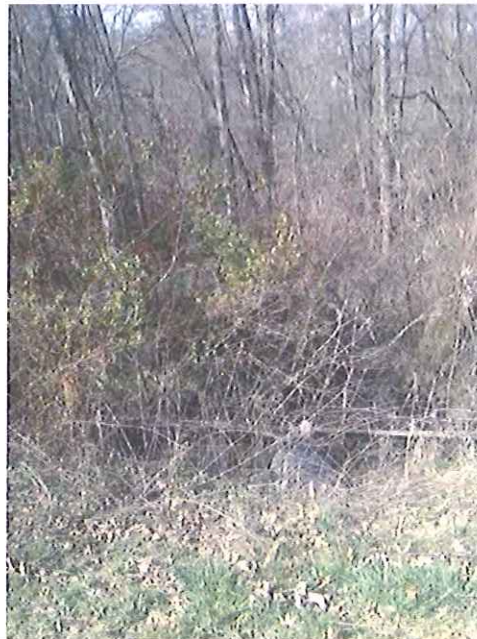
Name: Outflow from Sediment/Detention P

Photo taken facing West. Photo shows culvert outflow. Photo taken approximately in the middle of the Soccer fields.

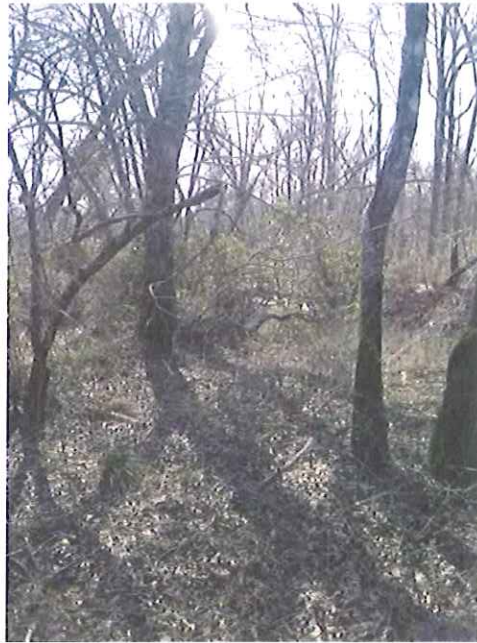
Name: Areas to the West

Description: Photo taken facing West close to data points 20 and 21.

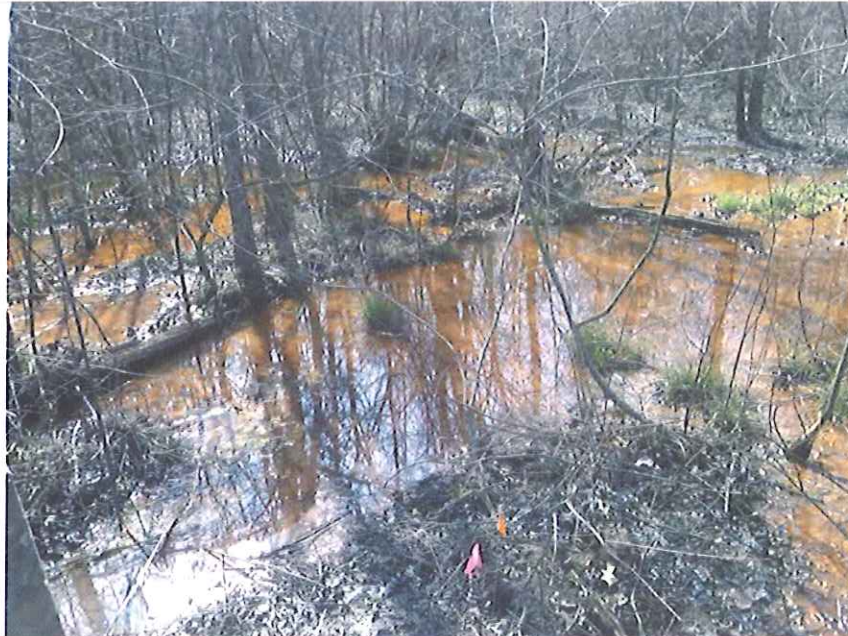
Name: Areas to the South

Description: Photo taken facing South. Area adjacent to Soccer Fields. Photo depicts hydrology and hydrophytic vegetation.

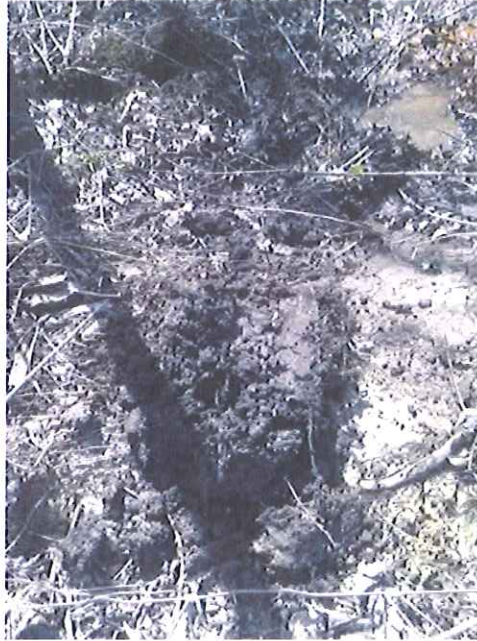
Name: Typical soils found in the Southern

Description: Photo of taken of hydric soils typical of wetland areas to the north and south of soccer fields.
