# Crossville, TN Influent Drum Screen Evaluation 6/22/18

Re: Crossville, TN – Influent Drum Screen Evaluation

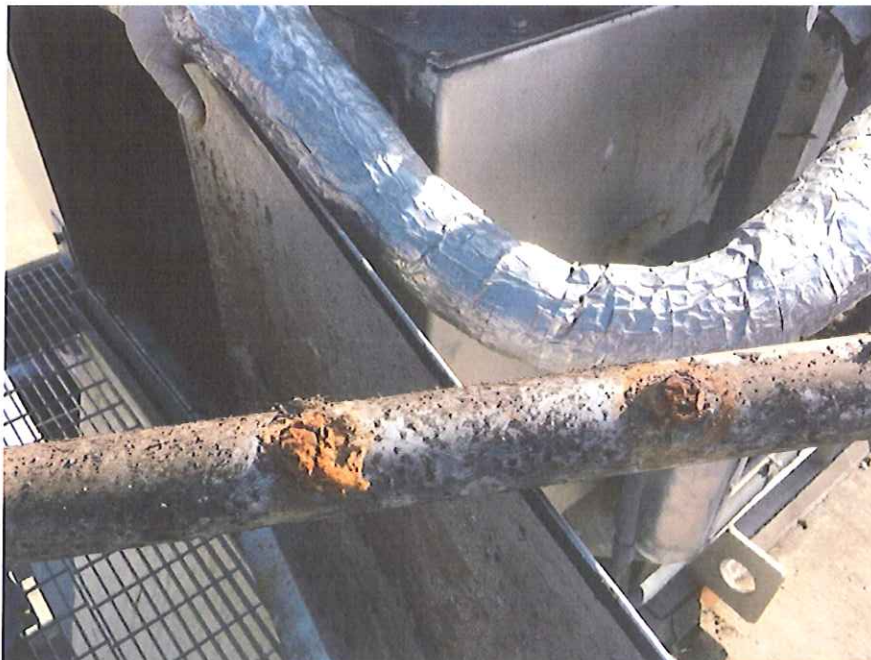
Spray bars with clogged spray heads.

1. Purchase new spray tips to replace the clogged tips on the existing spray bars. Prices from several vendors have been provided. Purchasing the same component from a supplier other than Parkson can save over \$465.

2. The threads on the spray bars appear to be damaged when the spray tips are removed. One option is to have a machine shop remove the existing spray tips and mount the correct size stainless steel nut over the hole and seal between the nut and spray bar. This will provide a clean thread to reinstall the new spray tips. Note that the spray tips need to be installed at a 10 to 15 degree angle from parallel to the spray bar. This will provide full spray against the drum for cleaning without interference from an adjacent spray tip pattern. See the operation and maintenance manual.

3. Install a Y strainer upstream of the spray bars to capture any debris that may be in the plant water. Debris caused the existing spray tips to fail and likely subsequent overflows. The strainer is intended to prevent the same failure from occurring. The long term plan should be to return the final disk screens to service to capture the debris prior to reaching the plant water pumps.
